Manhole Inspection Summary

Manhole # S11KK_014MH

Insp Date: **10/25/07 1:04 PM**

Location Address: **2957 CLIFTON AVE**

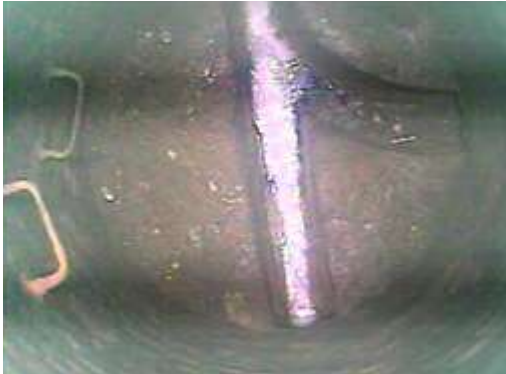
Defect 1

Count: **6** Missing: **4** ☒ **Corroded**

CORRODED STEPS

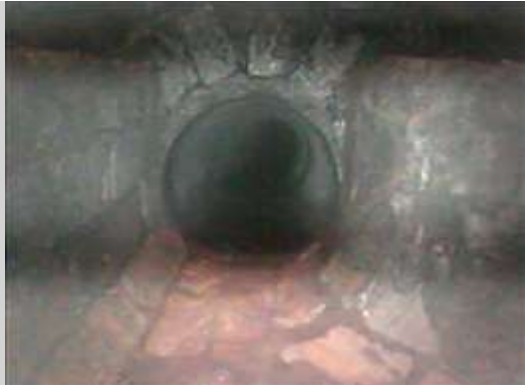
12 O'Clock Outflow

8 in. Circular Gravity Sewer
Pipe Out @ 12 O'Clock

Pipe Height: (in.) Direct
Pipe Material: **Clay** ☐ Pipe Lined
Invert Depth: **10.95** (ft.) Flow Characteristics: **Slow**
Deposits: ☒ None ☐ Mud ☐ Sludge ☐ Debris ☐ Grease
Silt Depth: (in.) Deposits Extent:
Infiltration: **None** Pipe Seal Cond: **Sound**

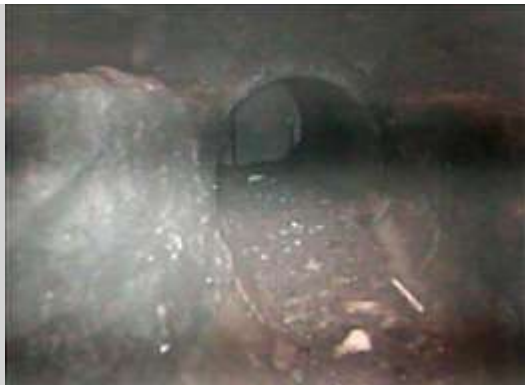
3 O'Clock Inflow

8 in. Circular Gravity Sewer
Pipe In @ 3 O'Clock

Pipe Height: (in.) Direct
Pipe Material: **Clay** ☐ Pipe Lined
Invert Depth: **10.84** (ft.) Flow Characteristics: **None**
Deposits: ☐ None ☒ Mud ☒ Sludge ☐ Debris ☐ Grease
Silt Depth: **1** (in.) Deposits Extent: **Light**
Infiltration: **None** Pipe Seal Cond: **Sound**

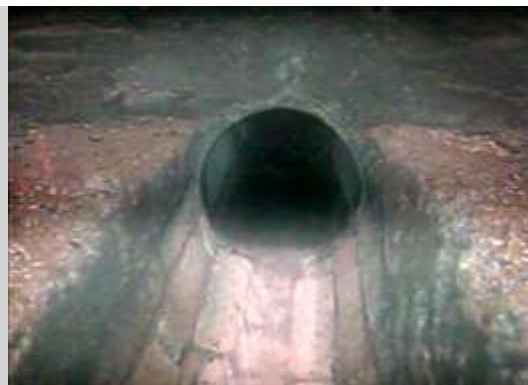
6 O'Clock Inflow

8 in. Circular Gravity Sewer

Pipe In @ 6 O'Clock

Deposits: ☒ None ☐ Mud ☐ Sludge ☐ Debris ☐ Grease

Infiltration: **None** Pipe Seal Cond: **Sound**
